SITUATION

The USDA, Natural Resources Conservation Service (NRCS) Bloomsburg Technical Office was contacted to assess a 1,020 foot waterway on the Ray Levan crop and poultry farm located along SR 42 in Columbia County, PA that was experiencing severe channel erosion. The established waterway was not previously provided with a channel liner. Four cross-slope diversion terraces and an upslope non-porous drag-strip drained into the eroded waterway.

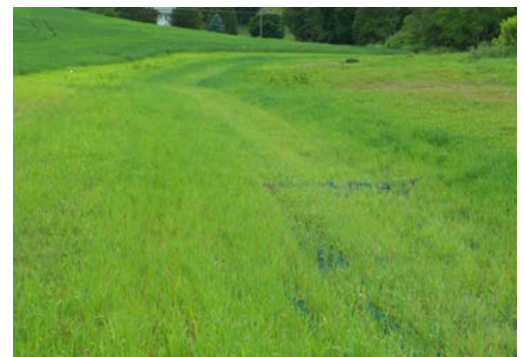
Erosion problems were resolved and use of the TRM allowed the installation of a channel with reasonable dimensions without the need to go to a much more costly rock lined channel. The waterway vegetation was fully established at 30 days (bottom right photo).

The waterway was regraded to the designed dimensions and topsoil was placed in the channel, fertilized and seeded. The owner chose two types of East Coast Erosion Blankets Turf Reinforcement Mats (TRMs) for channel liners. ECSC-3 Triple Net Straw/Coconut Turf Reinforcement Mats (TRMs) were installed in the lower 450-foot reach of the waterway. ECP-2 Double Net Polypropylene TRMs were installed in the upper 570-foot reach of the waterway. Shorter lengths of the ECP-2 TRMs were installed at the outlets of the four diversion terraces to safely convey flows into the waterway. ECS-1D Temporary Single Net Straw erosion control blankets were installed on both side slopes parallel to the TRMs for the entire length of the waterway. A total of 2,800 square yards of rolled erosion products were installed on the project.
